# DRIVELINE

## SECTION 05-04 Halfshafts, Front Drive

Capri.

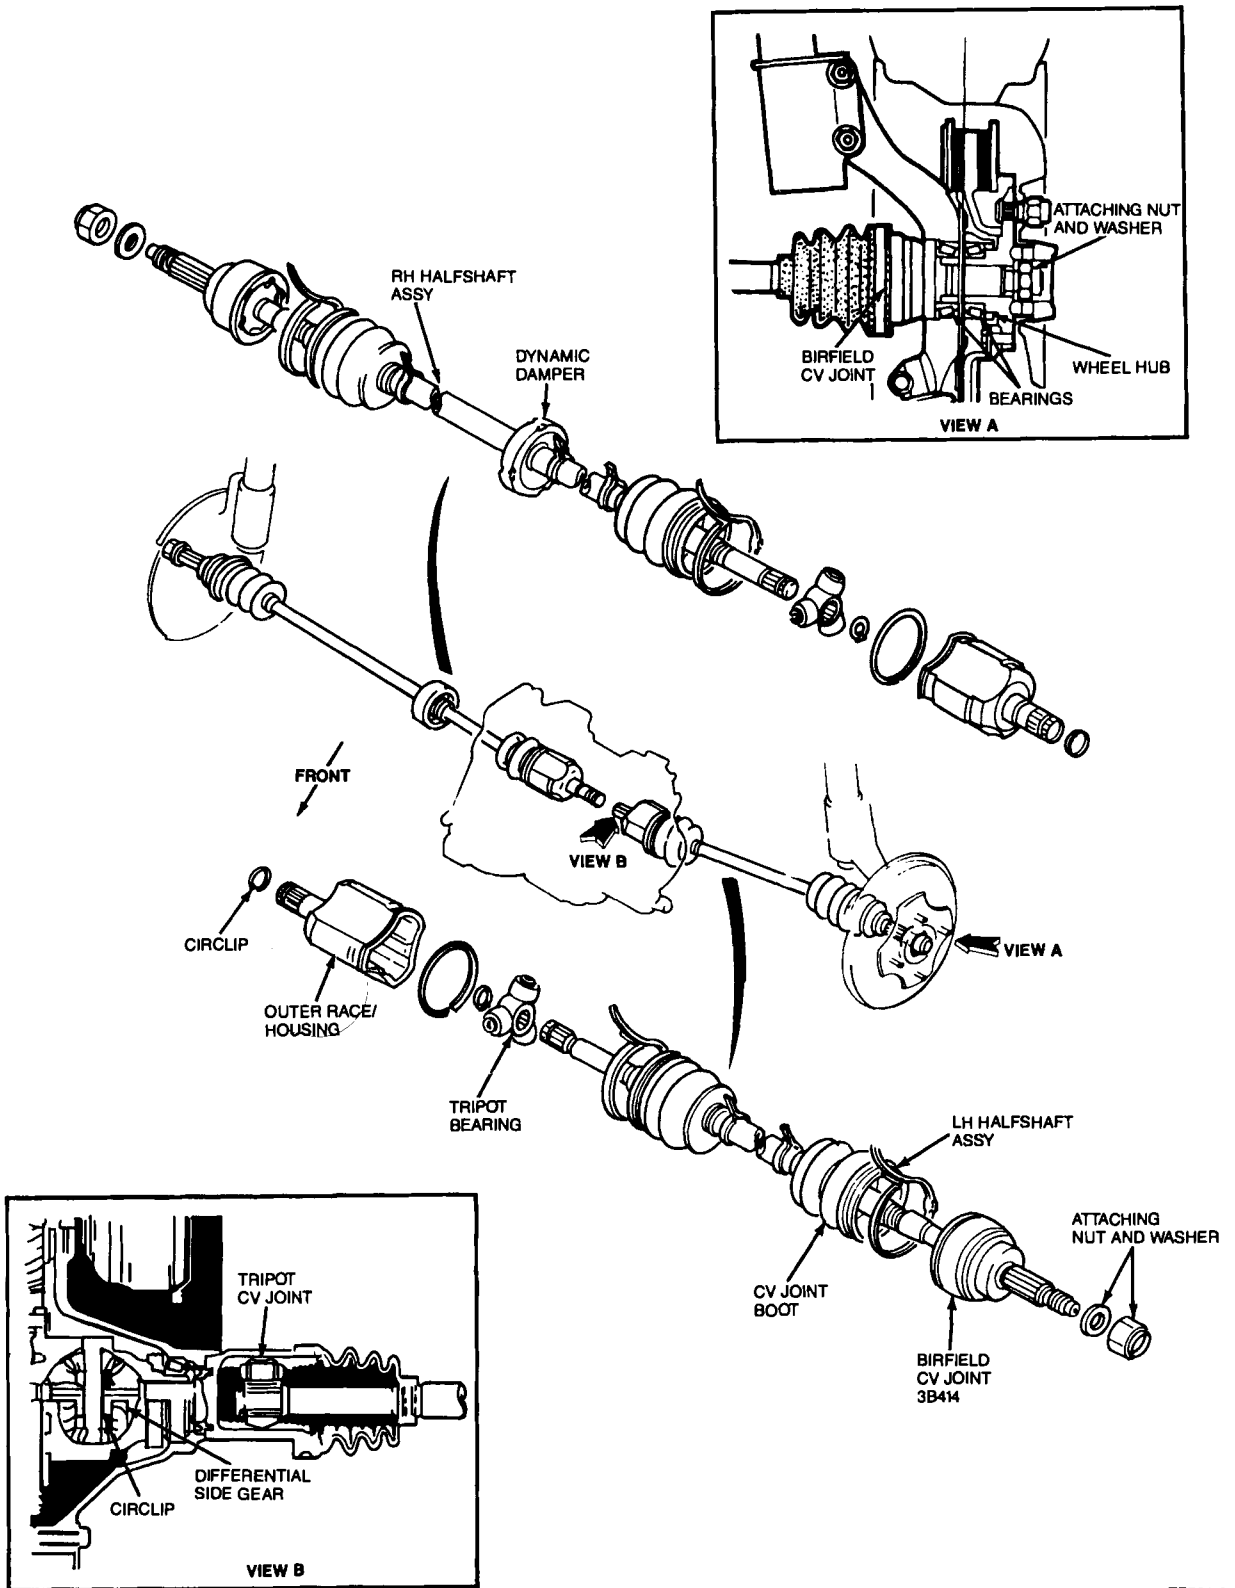
E7561-A

Constant velocity joints are installed at both ends of the halfshafts. Three different types of CV joints are used. All outboard CV joints are the Birfield-type. When the vehicle is equipped with an automatic transaxle, the inboard CV joints are the tripot type. A vehicle equipped with a manual transaxle will have Rzeppa or double offset inboard CV joints. The tripot joints are used with the automatic transaxle to prevent the transfer of engine vibration through the halfshafts to the vehicle body. Additional reduction of vibration is provided by a dynamic damper installed approximately in the middle of the right halfshaft (on naturally aspirated vehicles).

Halfshafts, Naturally Aspirated Vehicles

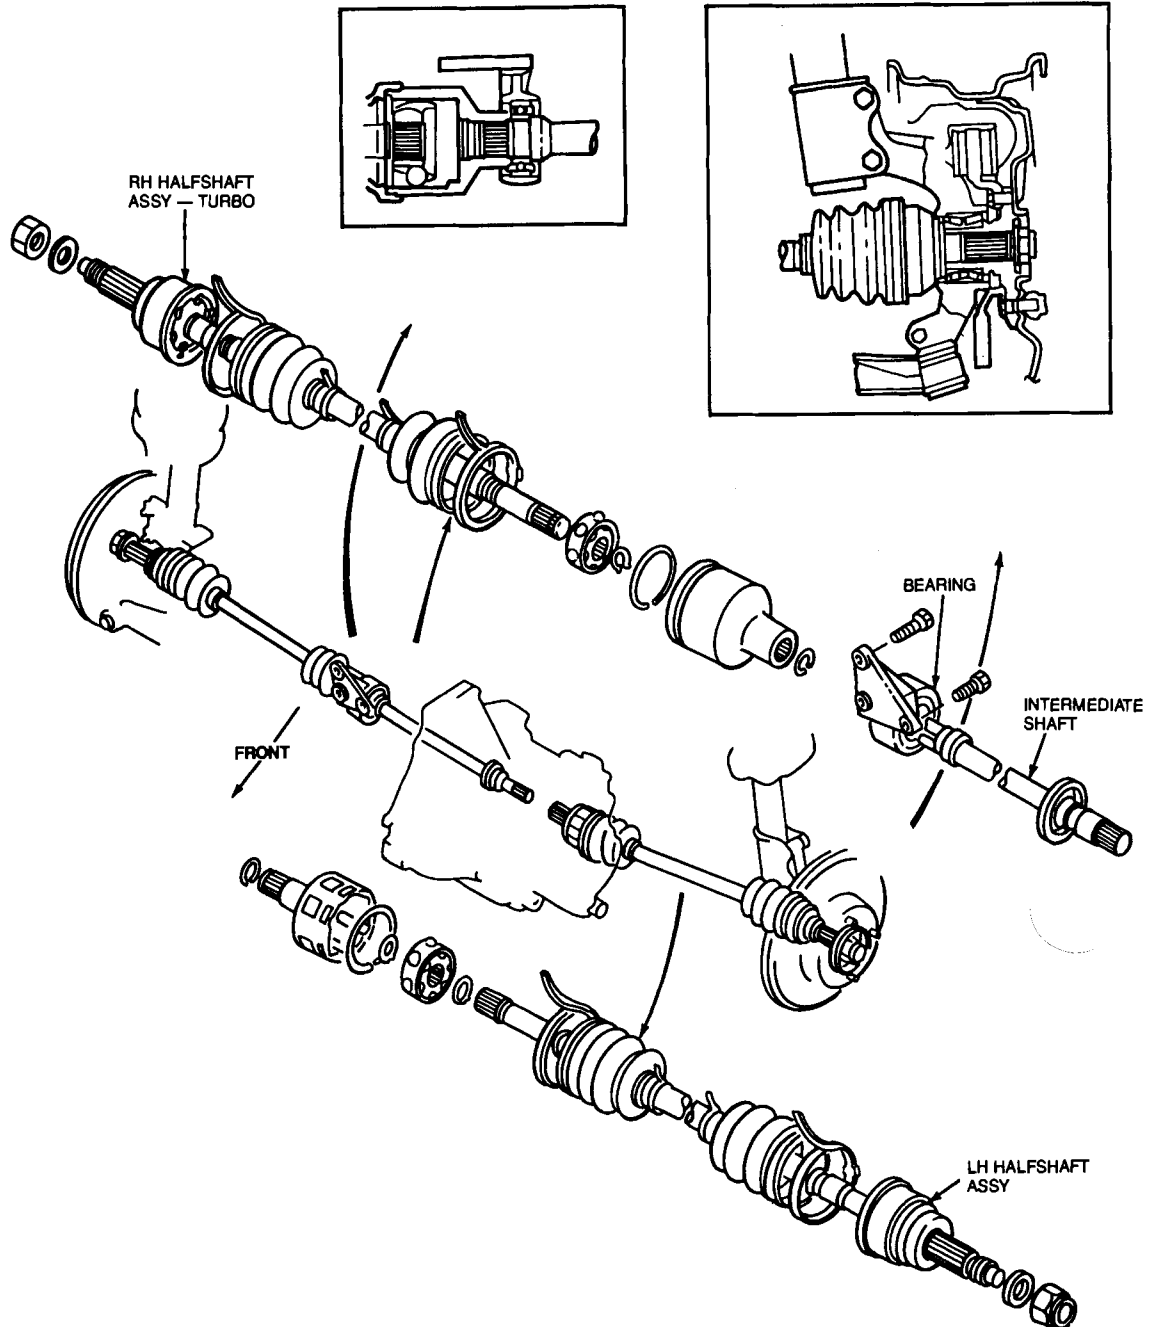
E7540-A

To prevent torsional vibration and torque steer on turbocharged vehicles, drive to the RH front wheel is through a joint (intermediate) shaft and a conventional halfshaft. Both shafts are of similar length and are supported by a bearing enclosed in housing which is bolted to the engine.

## Halfshafts, Turbocharged Vehicles

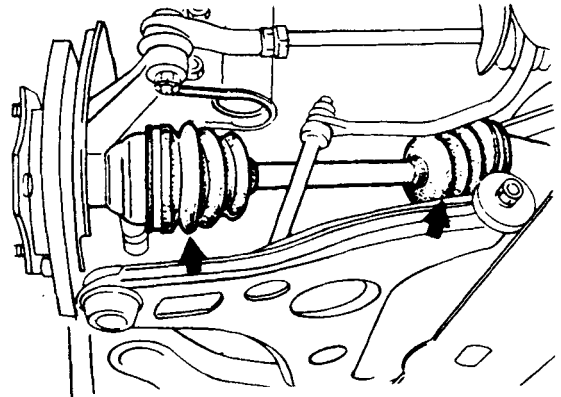
E7178-A

1. Check the boots on the halfshaft for cracks, damage, leaking grease, or loose boot bands. If any damage is found, replace the boot.
  - Out of balance front tires.
  - Out of round (radial runout) in front tires.
  - Lateral runout in front tires.
  - Improperly seated front CV joint in the front wheel hub.
  - Worn bearings in front hub.
2. If there is vibration at highway speeds, check for the following:
  - Out of balance front tires.
  - Out of round (radial runout) in front tires.
  - Lateral runout in front tires.
  - Improperly seated front CV joint in the front wheel hub.
  - Worn bearings in front hub.
3. If there is a noticeable metallic click when going over bumps, put the vehicle on a drive-on type rack and jounce the vehicle. Try to locate where the sound is coming from and then do further diagnosis.

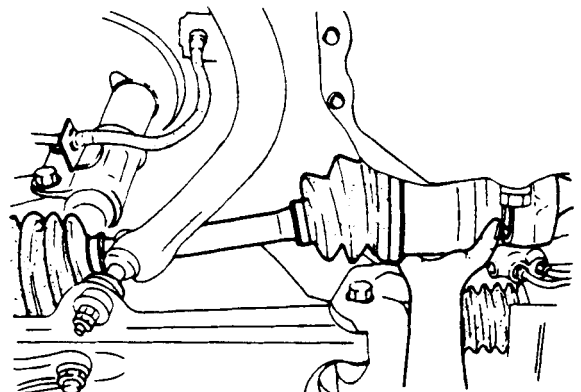
E7179-A

4. If there is shudder or vibration on acceleration, put the vehicle on a suitable hoist and check for spline and CV joint looseness. Turn the halfshaft by hand and make sure the splines and joints are not excessively loose.

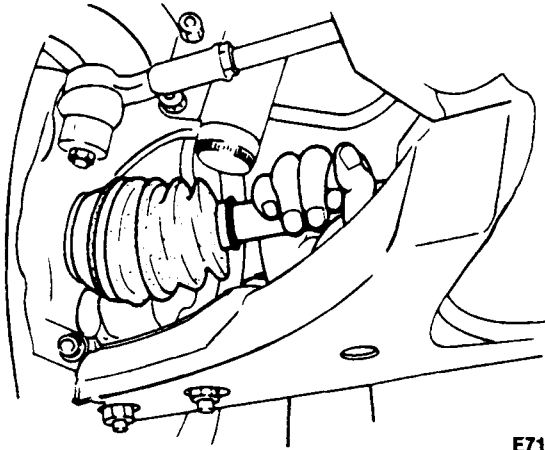
E7180-A

5. Make sure the halfshaft is not twisted or cracked. If the halfshaft is equipped with a vibration damper, make sure it is not damaged or loose on the shaft.

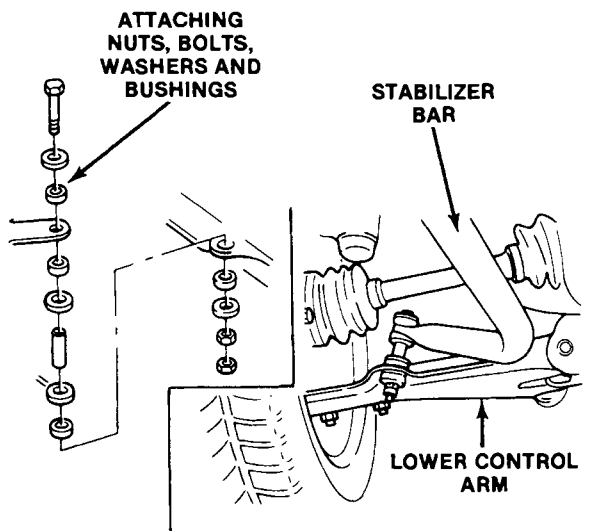
E6810-A

1. Raise the vehicle. Refer to Section 00-02. Remove the necessary engine compartment underbody covers.
2. Remove the stabilizer bar to control arm retaining nuts, bolt, washers and bushings.

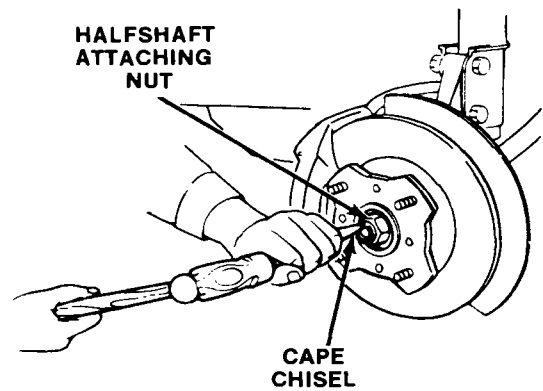
E6804-A

3. Remove the wheel and tire assembly.
4. Carefully raise the staked portion of the halfshaft attaching nut using a small cape chisel.

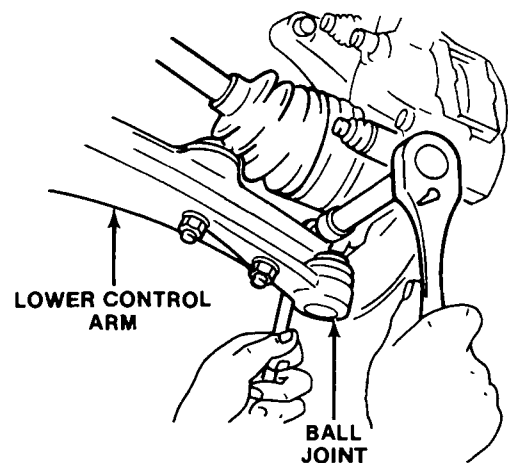
E6811-A

5. Loosen, but do not remove, the halfshaft attaching nut.  
NOTE: When loosening the nut, lock the hub by applying the brakes.
6. Remove the lower control arm ball joint clamp bolt.

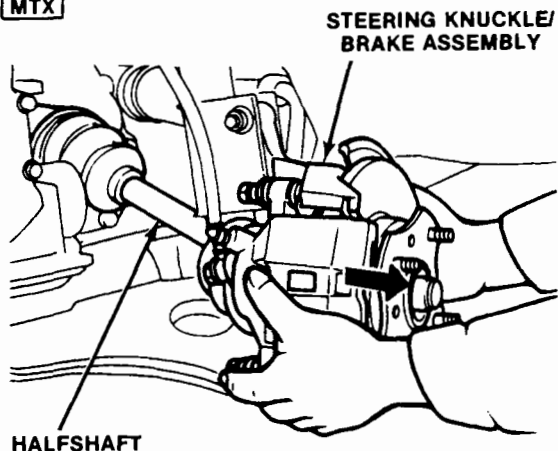
E6812-A

8. Separate the halfshaft from the transaxle on MTX vehicles as follows.

- a. Pull outward on the steering knuckle / brake assembly to separate the halfshaft from the transaxle.

**CAUTION:** To prevent damage to the transaxle oil seal, do not pull the halfshaft all the way out of the transaxle. Apply only enough force to loosen the shaft from the differential side gear.

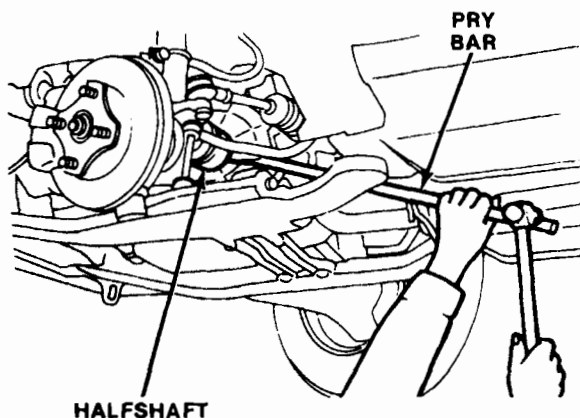
E6813-A

- b. If the halfshaft is difficult to remove, a pry bar can be used to loosen it from the differential side gear. Insert the bar between the halfshaft and the transaxle case. Lightly tap on the end of the bar until the halfshaft loosens from the differential side gear.

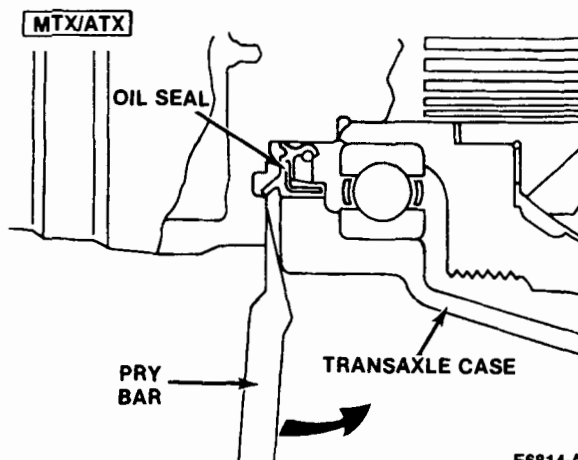
E6814-A

9. To separate the halfshaft from the transaxle on ATX vehicles, insert a pry bar between the transaxle case and the halfshaft. Lightly tap on the end of the bar until the halfshaft loosens from the differential side gear.

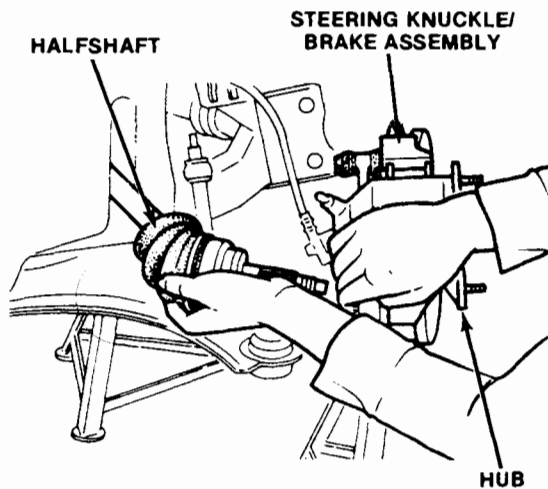
E6819-A

11. Pull the halfshaft out of the wheel hub.

**NOTE:** If the wheel hub binds on the halfshaft splines, it can be loosened using 2 Jaw Puller D80L-1002-L or equivalent.

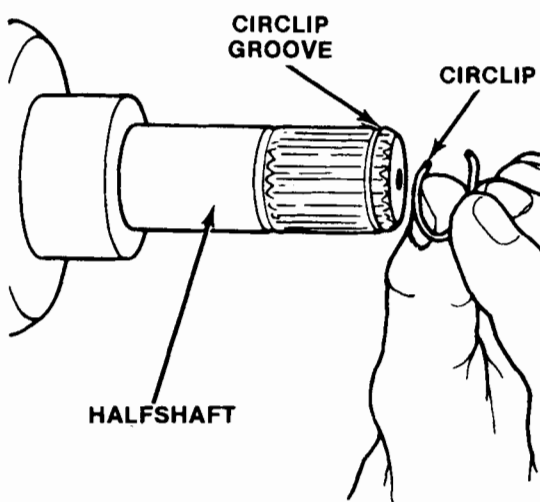
E6820-A

1. Install a new circlip on the inboard CV joint stub shaft.

**NOTE:** To install the circlip properly, start one end in the groove and work the circlip over the stub shaft end and into the groove. This will avoid over-expanding of the circlip.

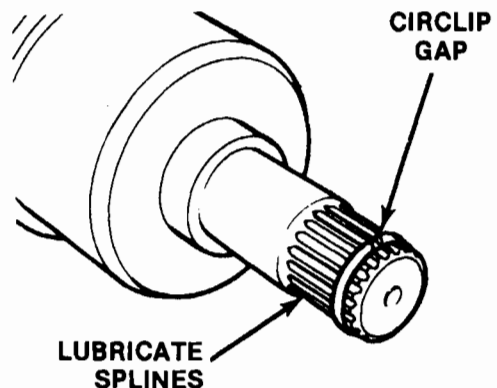
E6821-A

2. Make sure the dynamic damper, if equipped, is positioned properly.
3. Inspect the transaxle oil seal. If it shows any signs of wear or damage that may cause a leak, replace the seal. Refer to Section 07-03A or 07-03B.
4. Remove the Differential Plugs T87C-7025-C or equivalent.
5. Make sure the circlip gap is positioned at the top of the halfshaft splines and lightly lubricate the splines with Premium Long-Life Grease C1AZ-19590-E (ESA-M1C75-B) or equivalent.

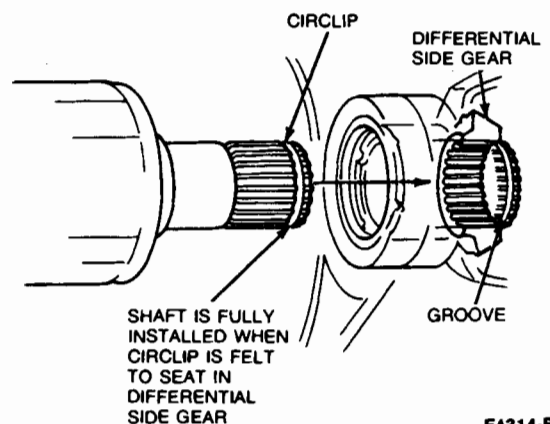
E4314-B

6. Carefully align the CV joint splines with the differential side gear splines and push the halfshaft into the differential.

**NOTE:** When it seats properly, the circlip can be felt as it snaps into the differential side gear groove.

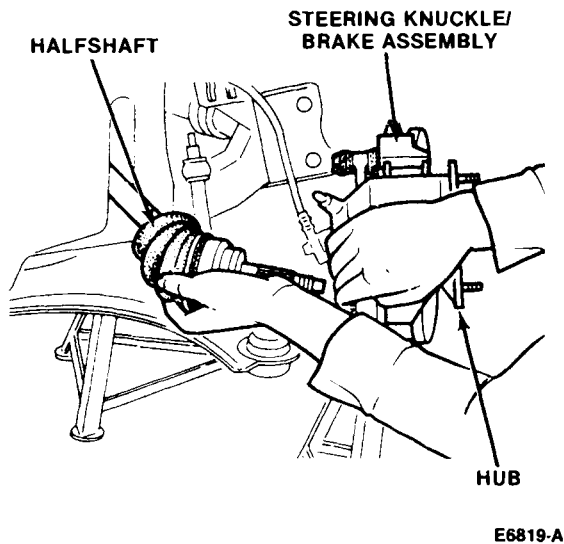
7. Position the halfshaft through the wheel hub and install a new attaching nut. Do not tighten the nut at this time.

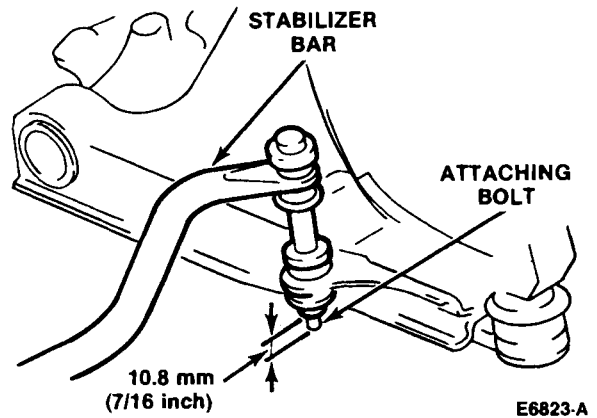
9. Install the pinch bolt and retaining nut. Tighten the attaching nut to 43-54 N·m (32-40 lb-ft).
10. Position the stabilizer bar and install the retaining bolt, nuts, washers and bushings. Tighten the nut until 10.8mm (7/16 inch) of the bolt threads extend beyond the nut.
11. Install the removed underbody covers.
12. Install new halfshaft retaining nut and tighten to 157-235 N·m (116-174 lb-ft).

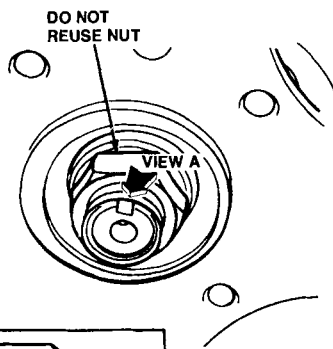
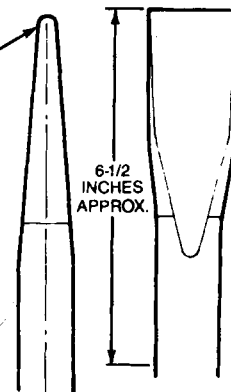
E7563-A

13. Stake the halfshaft retaining nut using a cold chisel with the cutting edge rounded as shown.

RADIUS  
1.5mm ± .25  
(0.06 ± .01)

THE STAKING TOOL CAN BE FABRICATED FROM AN EXISTING HARDENED CHISEL. THE CORRECT RADIUS ON THE CHISEL TIP WILL PREVENT IMPROPER STAKING. DO NOT ATTEMPT TO STAKE WITH A SHARP EDGED TOOL.

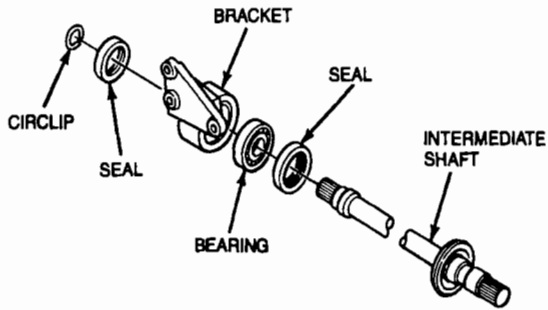
E7541-A

- Remove circlip from intermediate shaft and press off bearing assembly.

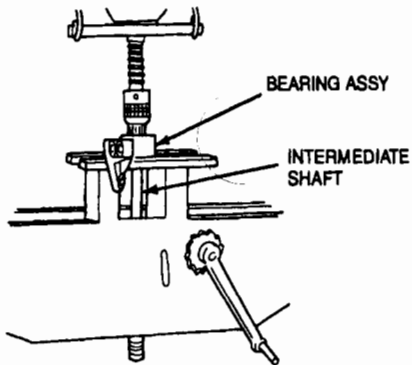
E7542-A

- Press bearing out of the bracket.
- Inspect bracket for damage or wear, replace if necessary.

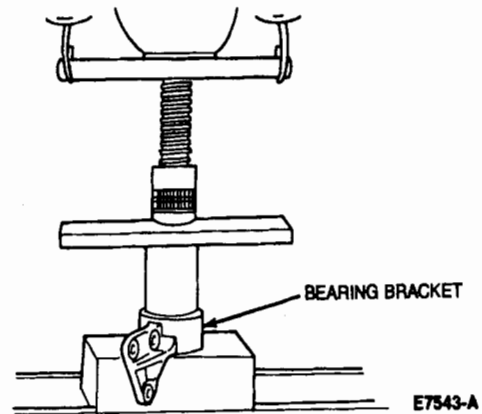
- Press new bearing into bracket.
- Install new seals.
- Install bearing assembly on intermediate shaft.

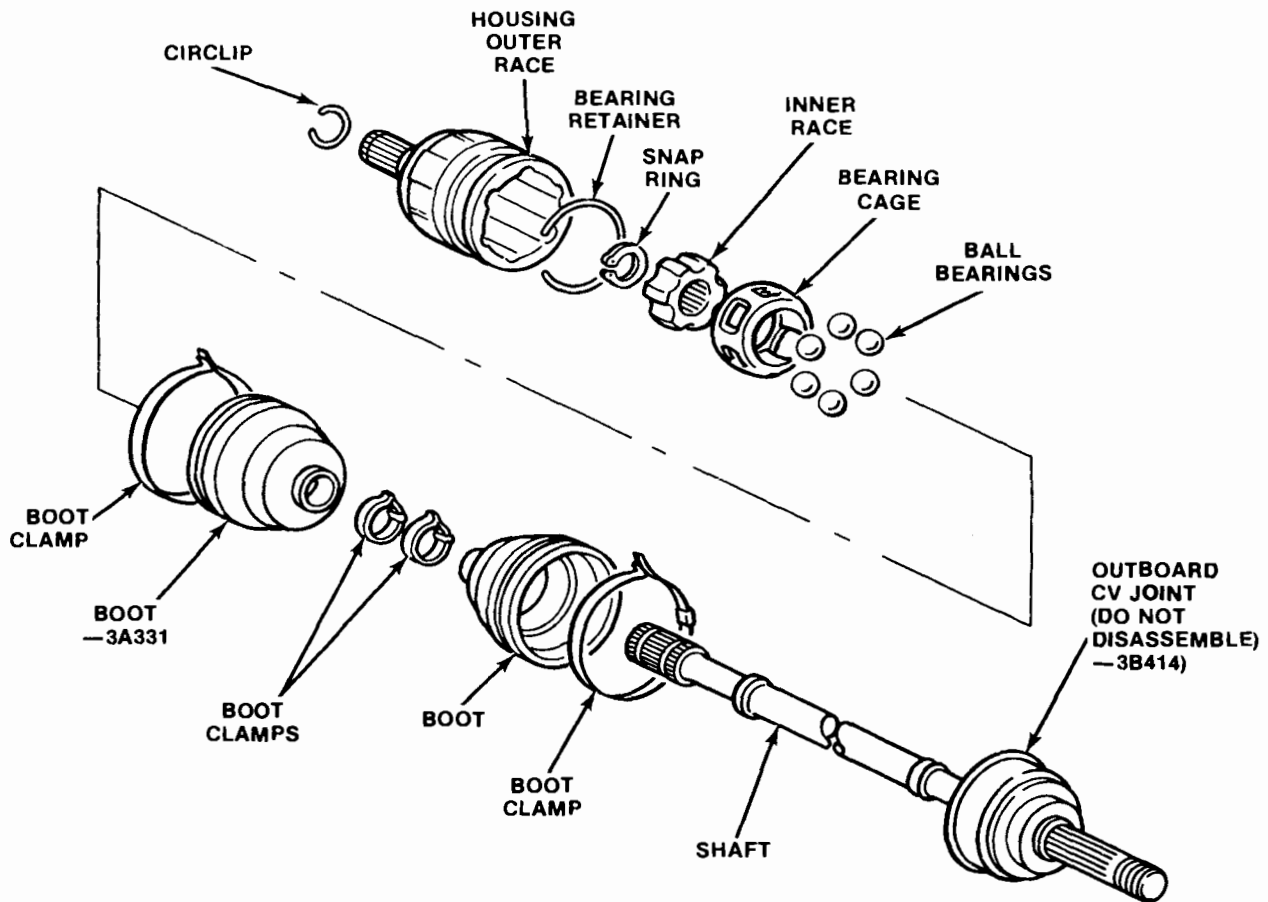
E6818-A

## Disassembled View

NOTE: The CV joint components are matched during manufacture and therefore cannot be interchanged with components from another CV joint. Extreme care should be taken not to mix or substitute like components between CV joints.

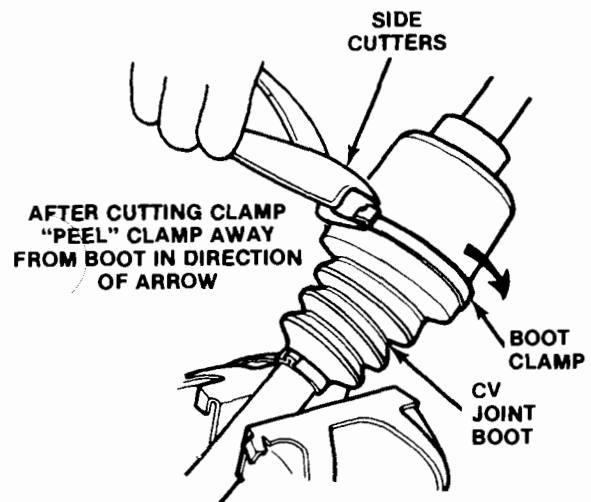
E6851-A

2. Remove the large boot clamp using side cutters. After removing the clamp, roll the boot back over the shaft.

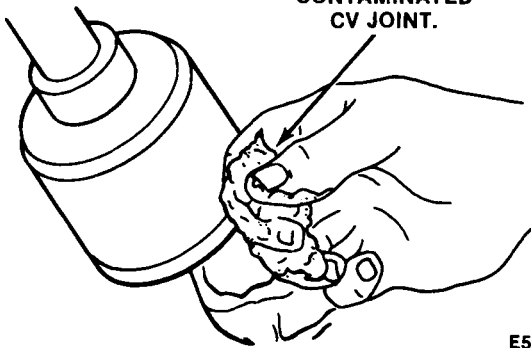
E5492-A

**CHECK LUBRICANT FOR CONTAMINATION BY RUBBING BETWEEN TWO FINGERS. ANY GRITTY FEELING INDICATES A CONTAMINATED CV JOINT.**

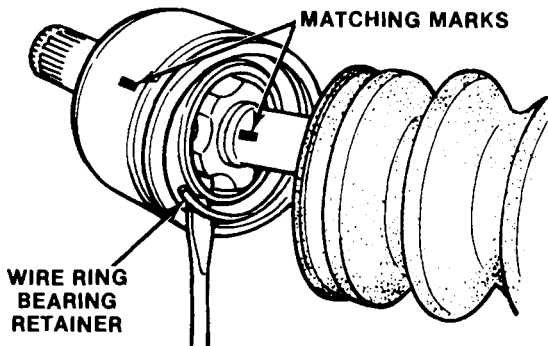
E6852-A

- 3. Remove the wire ring bearing retainer.

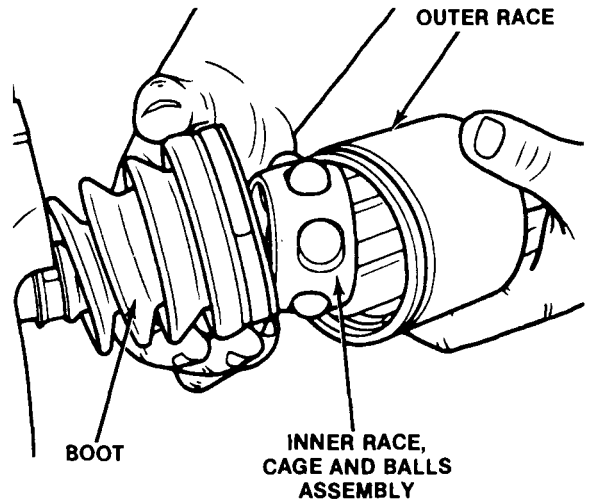
E6853-A

- 4. Remove the outer race.

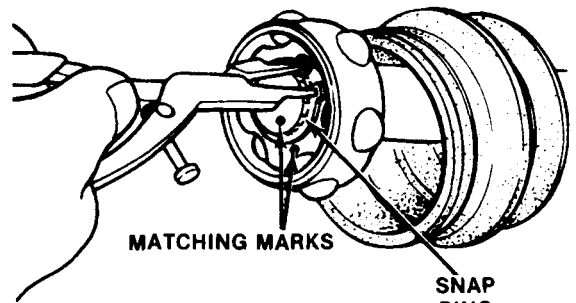
E6854-A

- 5. Remove the inner race snap ring from the end of the halfshaft.

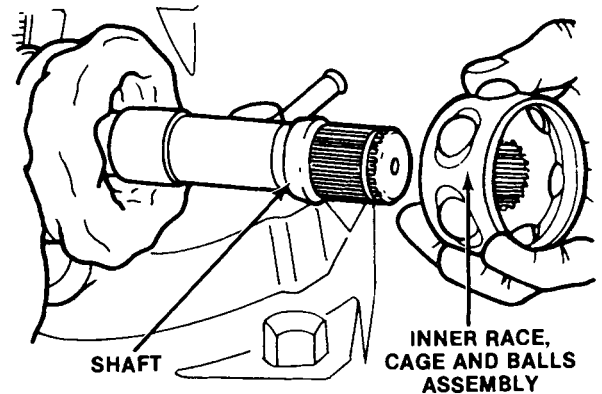
E6855-A

- 6. Remove the inner race, cage and ball bearings from the shaft as an assembly.

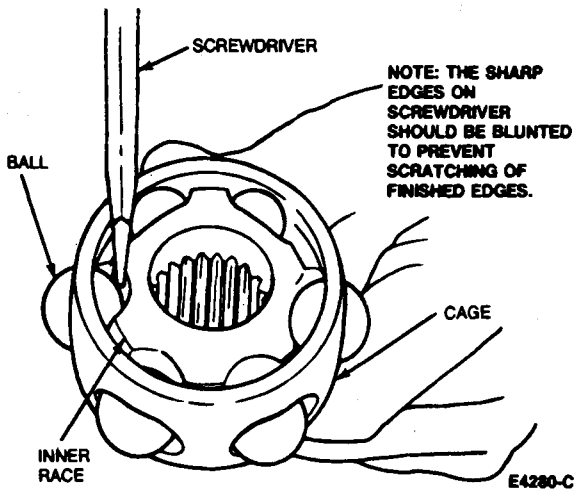
7. Pry the ball bearing out of the bearing cage using a screwdriver.

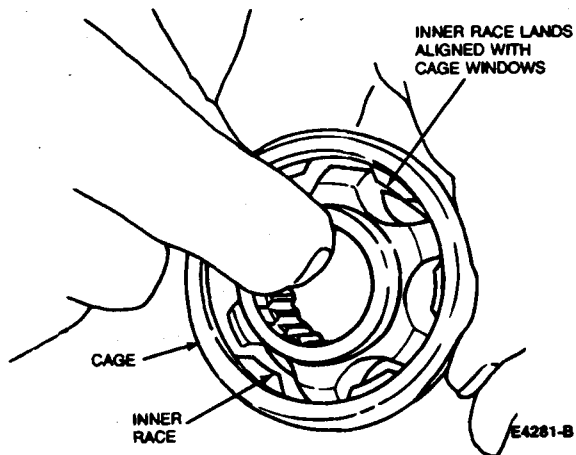
8. Rotate the inner race to align the bearing lands with windows in the bearing cage. Remove the inner race through the larger end of the cage.

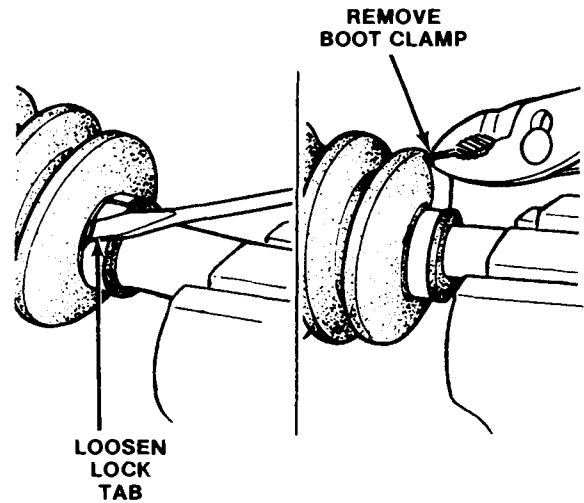
E6857-A

9. If necessary, remove the small clamp and remove the boot from the halfshaft.

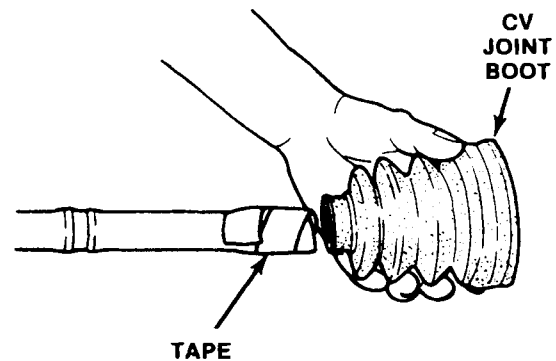
E6870-A

10. If the boot is to be reused, wrap the halfshaft splines with tape before removing.

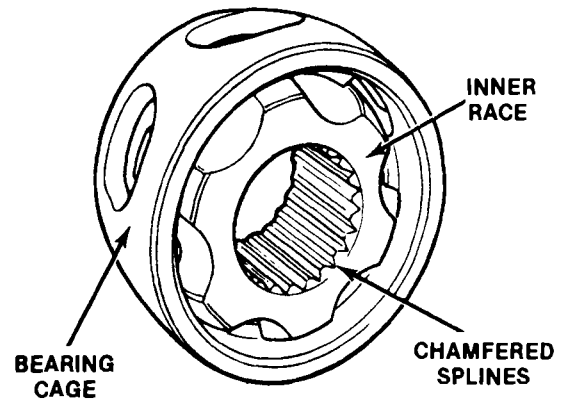
E6858-A

3. Position the inner race in the bearing cage and align match marks.

NOTE: Install the race with the chamfered splines facing the large end of the cage.

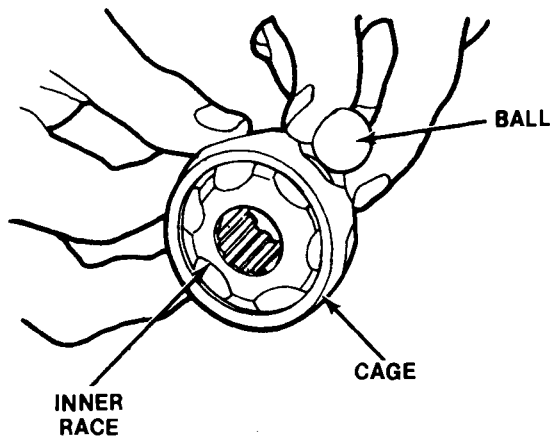
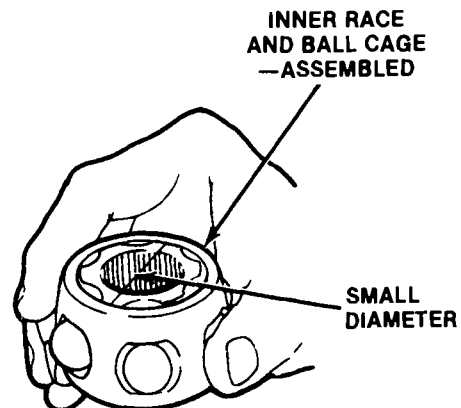
E6859-A

4. Install the ball bearings in the bearing cage. The balls can be pressed into the cage windows with heel of the hand.

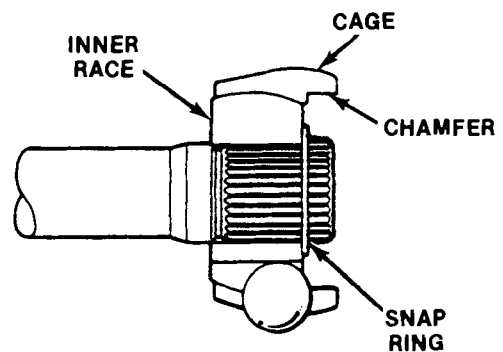
E6860-A

5. Install the inner race, cage and balls on the halfshaft as an assembly.

NOTE: Make sure the chamfer on the bearing cage faces the snap ring and that paint marks made during removal line up.

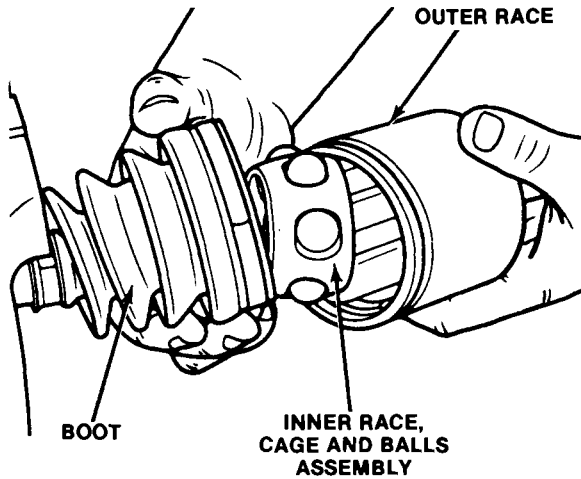
E8853-A

6. Install the inner race snap ring.
7. Lubricate the outer race with 40-60 grams (1.4-2.1 oz) of the specified grease.
8. Install the outer race.

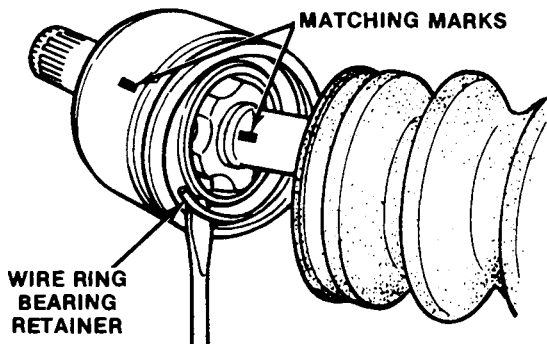
E8852-A

9. Add another 20-30 grams (0.7-1.0 oz) of the specified lubricant to the outer race.
10. Install the wire ring bearing retainer.

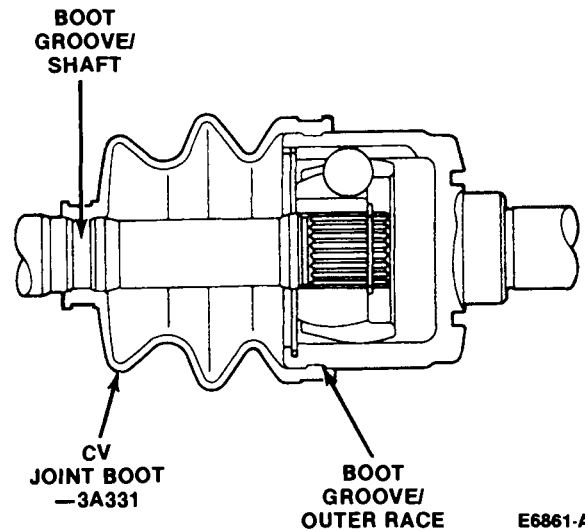
E8861-A

11. Position the boot. Make sure the boot is fully seated in the grooves in the shaft and outer race.

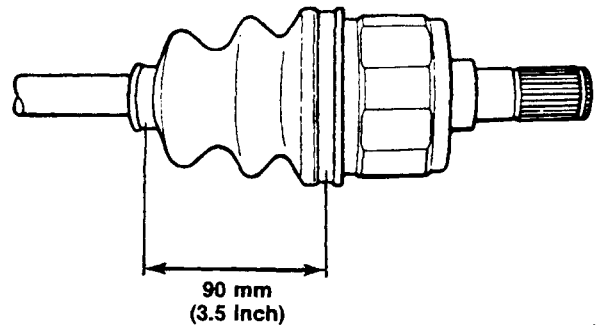
E8865-A

12. Extend or compress the CV joint as necessary until the distance between the boot clamp grooves measures 90mm (3.5 inch). Do not allow this dimension to change until the boot clamps are installed.

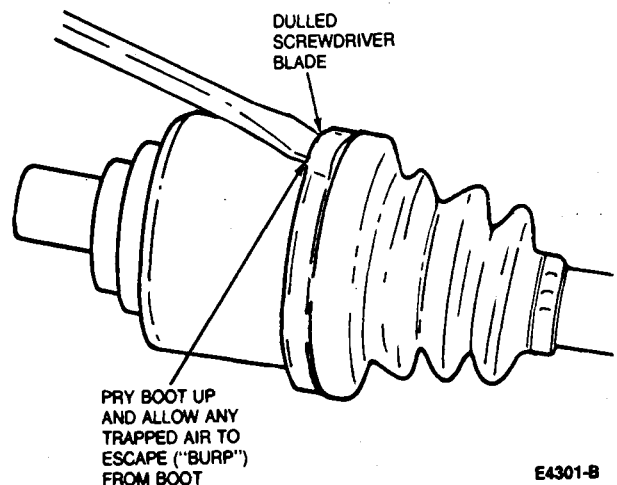
E4301-B

13. Insert a dulled screwdriver blade between the boot and the outer bearing race to allow trapped air to escape from the boot.

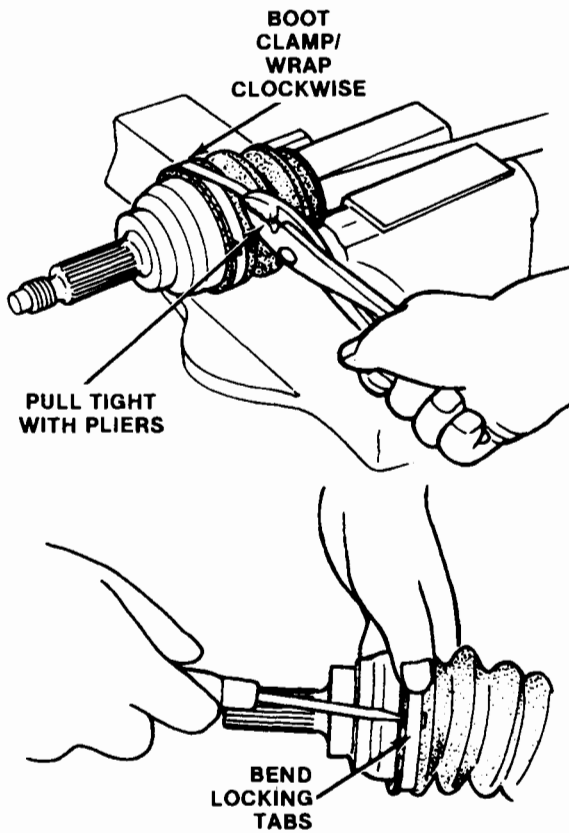
E6862-A

15. Wrap the clamps around the boots in a clockwise direction, pull tight with pliers and bend the locking tabs to secure in position.

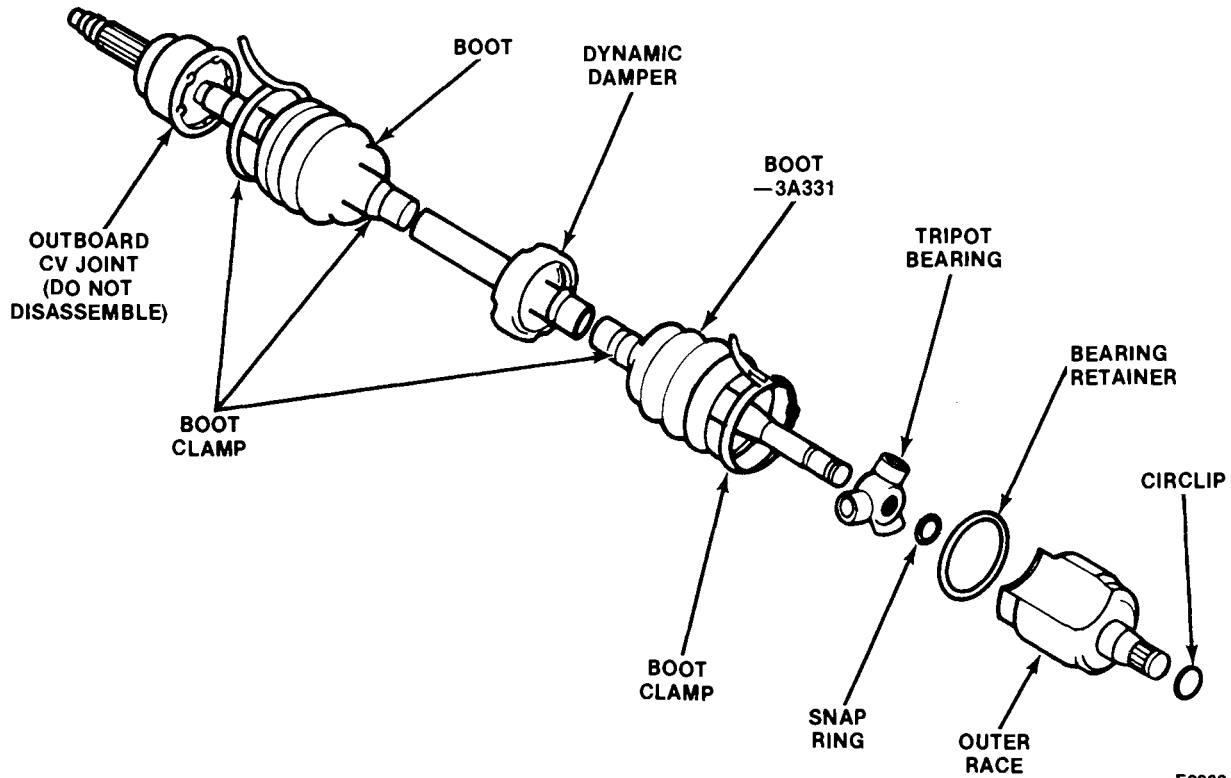
E6863-A

## Tripot Joint — Disassembled View

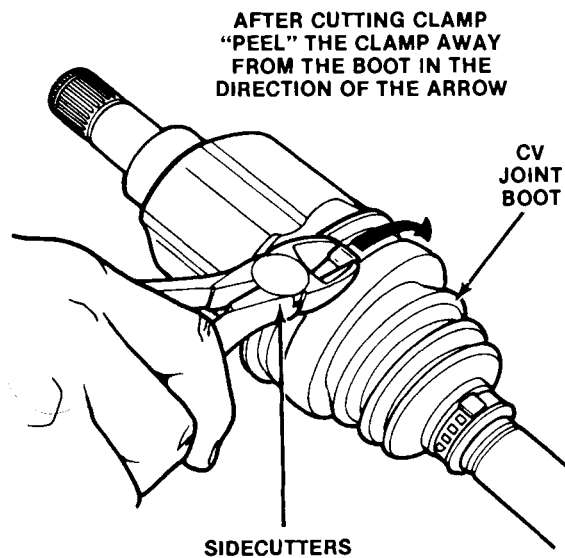
E6873-A

1. Clamp the halfshaft in a vise. Do not allow the vise to contact the boot or its clamps.  
**CAUTION: The vise should be equipped with jaw caps to prevent damage to any machined surfaces.**
2. Remove the large boot clamp using side cutters. Then, roll the boot back over the shaft.

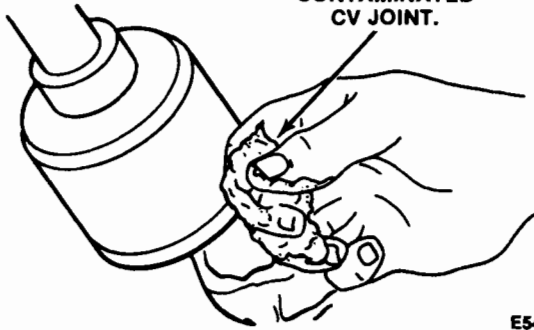
E5492-A

**CHECK LUBRICANT FOR CONTAMINATION BY RUBBING BETWEEN TWO FINGERS. ANY GRITTY FEELING INDICATES A CONTAMINATED CV JOINT.**

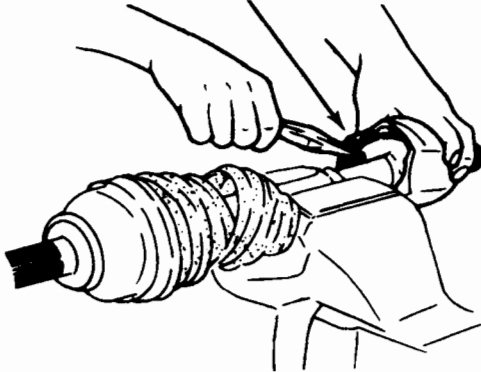
E6866-A

- 3. Remove the wire ring bearing retainer.

**WIRE RING BEARING RETAINER/REMOVAL**

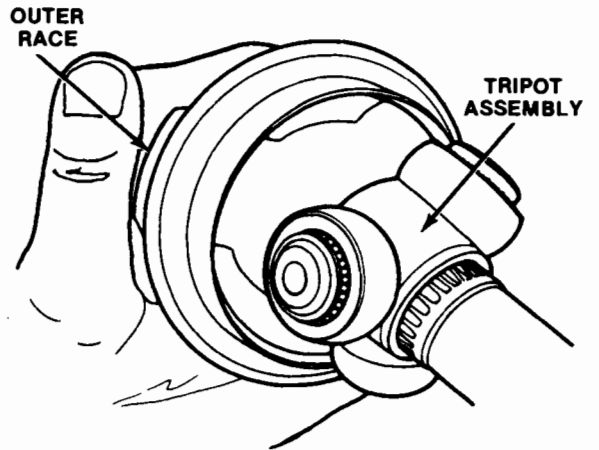
E6867-A

- 4. Remove the outer race.

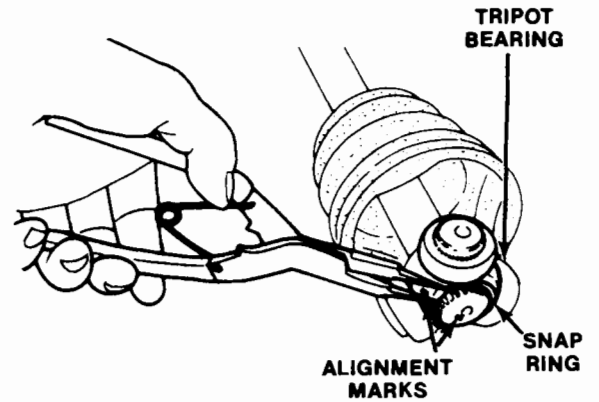
E6868-A

- 5. Remove the tripot bearing snap ring.

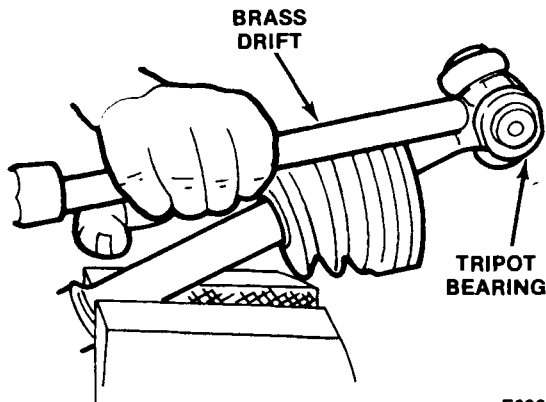
E6869-A

6. Using a brass drift and hammer, remove the tripod bearing from the shaft.

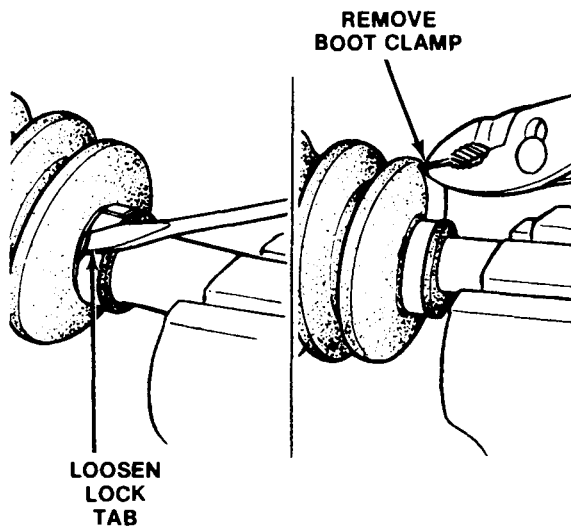
E6857-A

7. If necessary, remove the small clamp and the CV joint boot from the halfshaft.

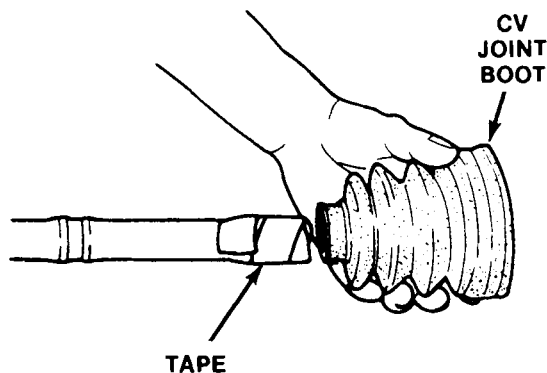
E6870-A

8. If the boot is to be reused, wrap the halfshaft splines with tape before removing it from the shaft.

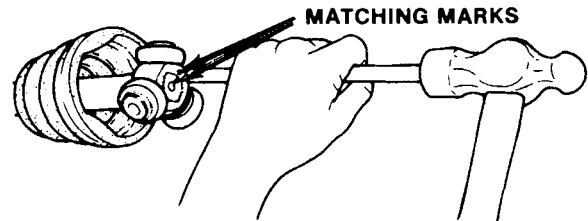
E6871-A

1. If boot is reused, cover the halfshaft splines with tape and install the CV joint boot.
2. Install the tripod assembly on the halfshaft.

NOTE: Tap the assembly onto the shaft using a hammer and brass drift.

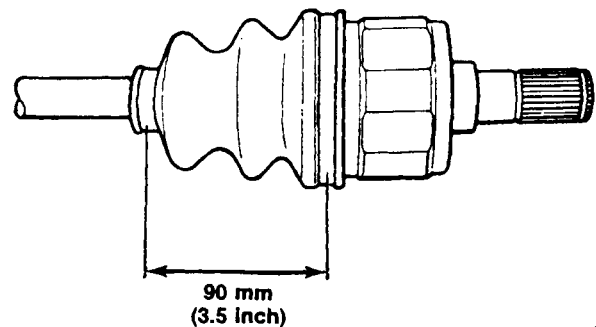
E6865-A

3. Install the tripod assembly retaining ring.
4. Fill the CV joint outer race with 100 grams (3.5 oz) of the specified grease.
5. Install the outer race over the tripod joint and install the wire ring bearing retainer.
6. Position the CV joint boot. Make sure the boot is fully seated in the grooves in the shaft and outer race.
7. Extend or compress the joint as necessary until the distance between the CV joint boot clamp grooves measures 90mm (3.5 inch).

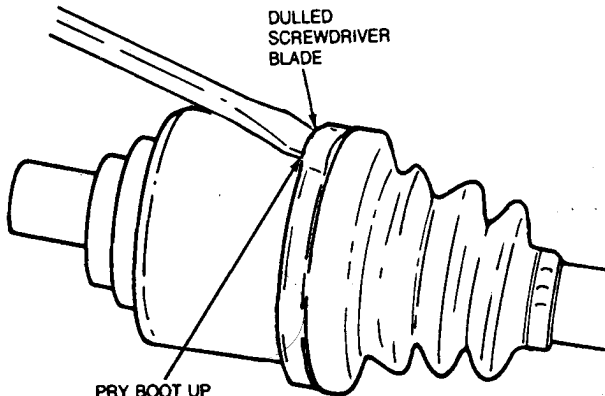
E4301-B

8. Insert a dulled screwdriver blade between the boot and the outer bearing race to allow trapped air to escape from the boot.

PRY BOOT UP AND ALLOW ANY TRAPPED AIR TO ESCAPE ("BURP") FROM BOOT

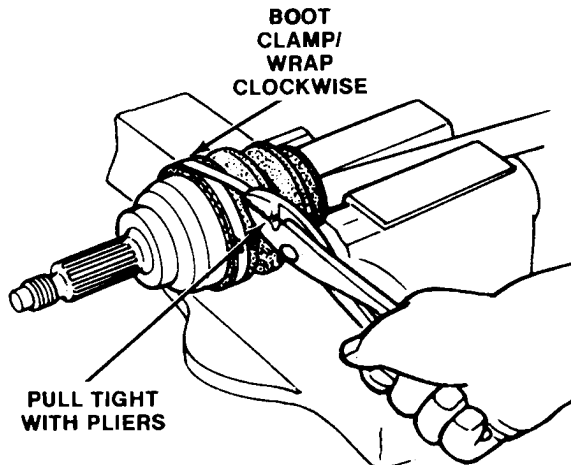
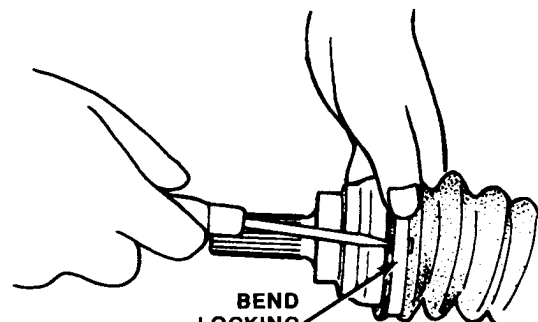
E6862-A

9. Install new boot clamp(s). Wrap the clamps around the boots in a clockwise direction, pull tight with pliers and bend the locking tabs to secure in position.

PULL TIGHT WITH PLIERS

BEND LOCKING TABS
