CLUTCH SYSTEM

GROUP 08

SECTION 08-00 Clutch System—Service

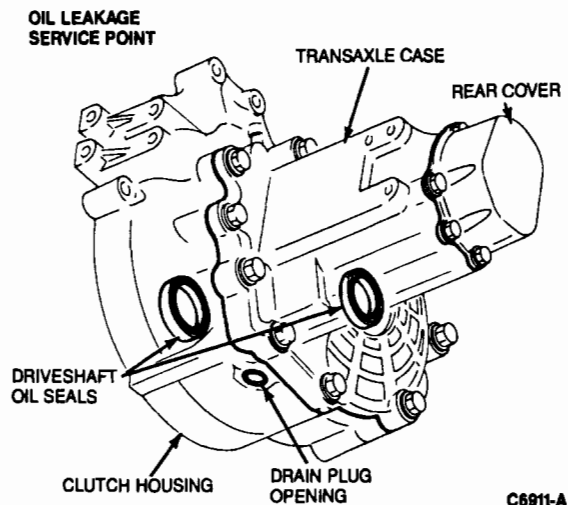
To diagnose suspected transaxle leakage, the affected area should be cleaned of all grease, dirt and oil first. The vehicle should be operated long enough to bring the transaxle fluid to operating temperature. Inspect the areas shown. Remember to check the transaxle fluid level and fill to the full mark before performing the diagnosis. Refer to Section 07-03A or 07-03B.
